September 1, 2004

Final Report

SERDP Pollution Prevention Project 1137

Non-Destructive Testing of Corrosion Under Coatings

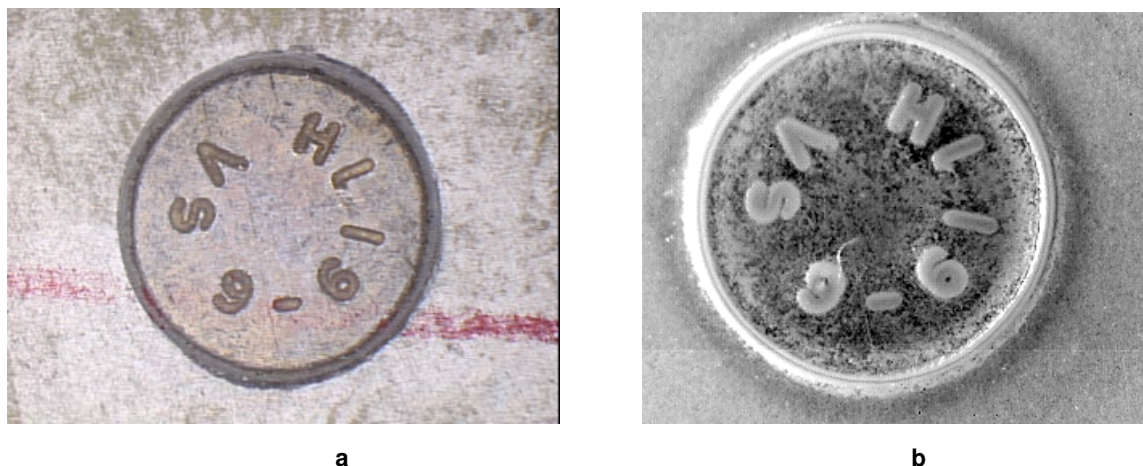
Figure 59 shows a visual image on an unpainted fastener head next to an IR image of the same fastener covered with 3 mil of primer and topcoat. The fastener markings can be clearly seen through the coating.

Figure 59 A visible image (a) of an unpainted fastener head, an IR image (b) of the same fastener covered with 3 mils of primer and topcoat.

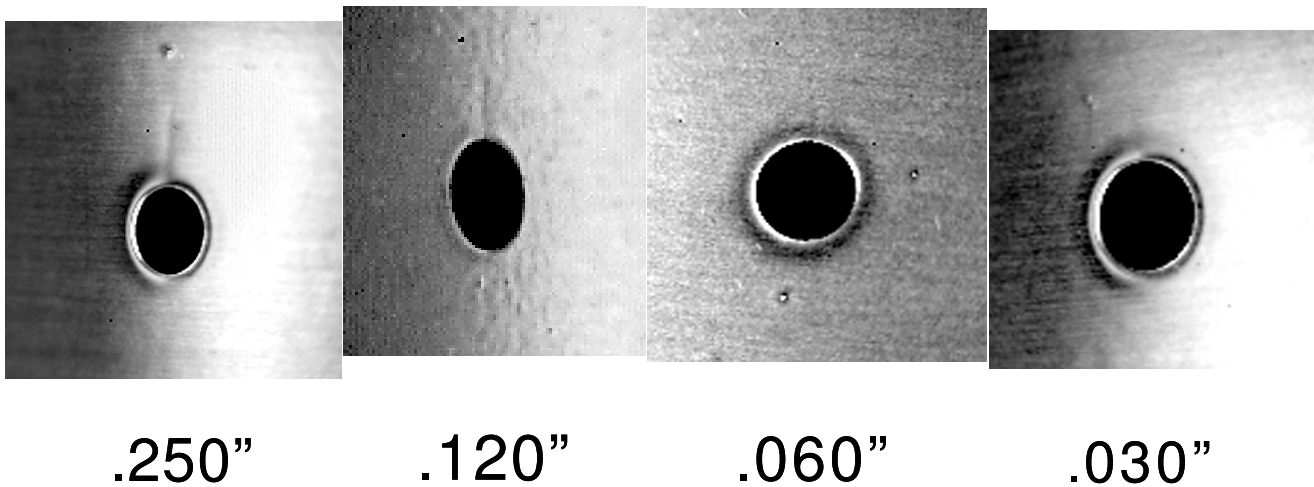
Figure 63 Successively smaller length fatigue cracks imaged under 3.5 mil primer and topcoat using a 25 mm IR lens.

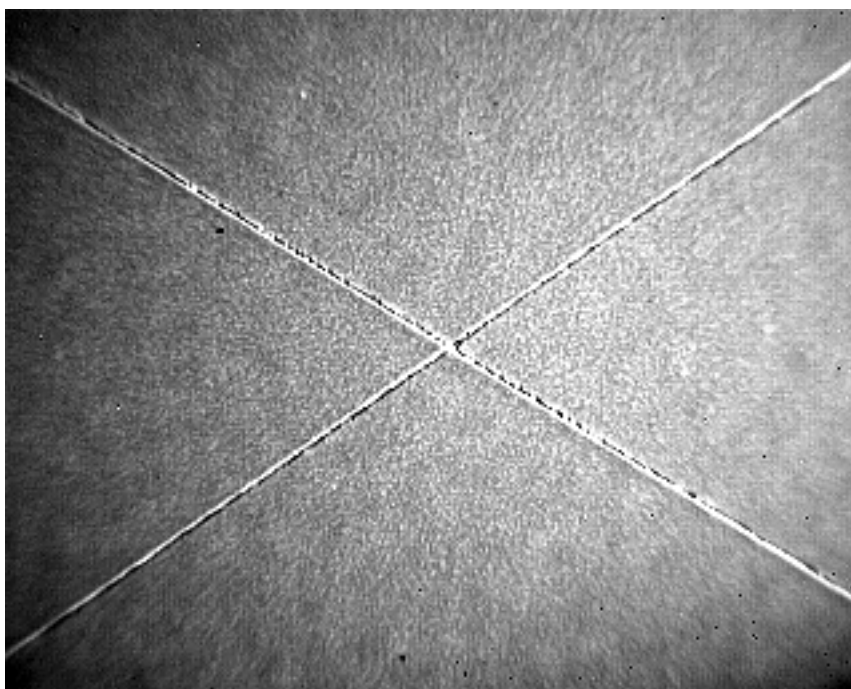
31 C4 (CLOSE)

Observations same as 31 C 4.

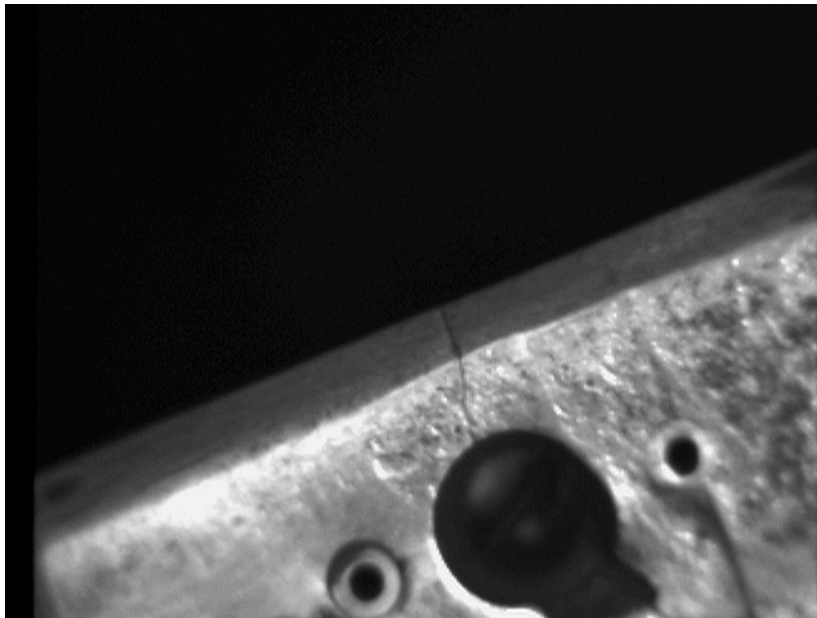
Visible and IR images of crack.
